Thinking outside the box

Question: What do you do when a lift needs modernising and yet it's the only lift in the building?

The problems faced by Canterbury City Council when one of their passenger lifts was troublesome and in need of a full modernisation is a case in point. All aspects of the client's requirements had to be addressed including lift engineering, civil engineering, logistics, cost and the practical and emotional needs of the residents.

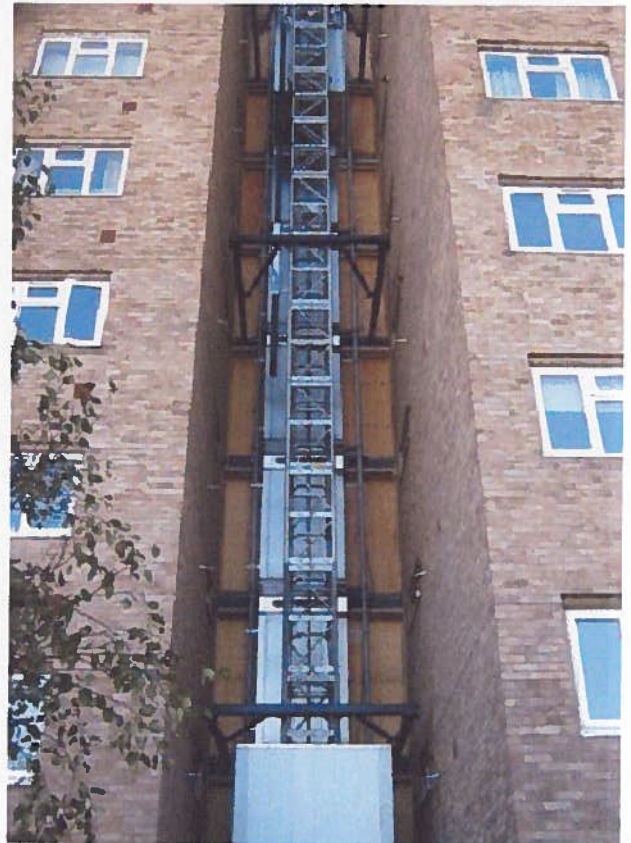
There were many challenges to overcome to enable a temporary lift structure to be built (which was the solution that was settled on – see photo) power, telephones, drainage, sewerage and structural loading had to be considered along with overcoming newly introduced hazards such as the potential for access to the temporary lift structure by climbing and the need to restrict the aperture of those bathroom windows which faced onto the temporary lift so that the passing lift car could not be reached.

Lerch Bates were invited to manage the entire project and the temporary lift was installed after building enabling works. The temporary lift ran for a fortnight in tandem with the existing lift so that reliability and acceptance was assured. When consensus was achieved the existing lift was removed from service and modernisation commenced. The added benefit of having a temporary lift in the building, apart from the obvious advantages of deliveries and public access without using the stairs, was that the modernisation of the existing lift was made easier with the use of a temporary lift to deliver materials and labour. In addition maintenance of the apartments was easier because access by tradesmen with their tools and materials was always available.
