Highland spring clean

More than 100 years' worth of clutter has been swept away to transform the congested and under-used Scottish National Portrait Gallery into a light and spacious 21st century art attraction. Stephen Cousins reports.
Photography by Graeme Duncan

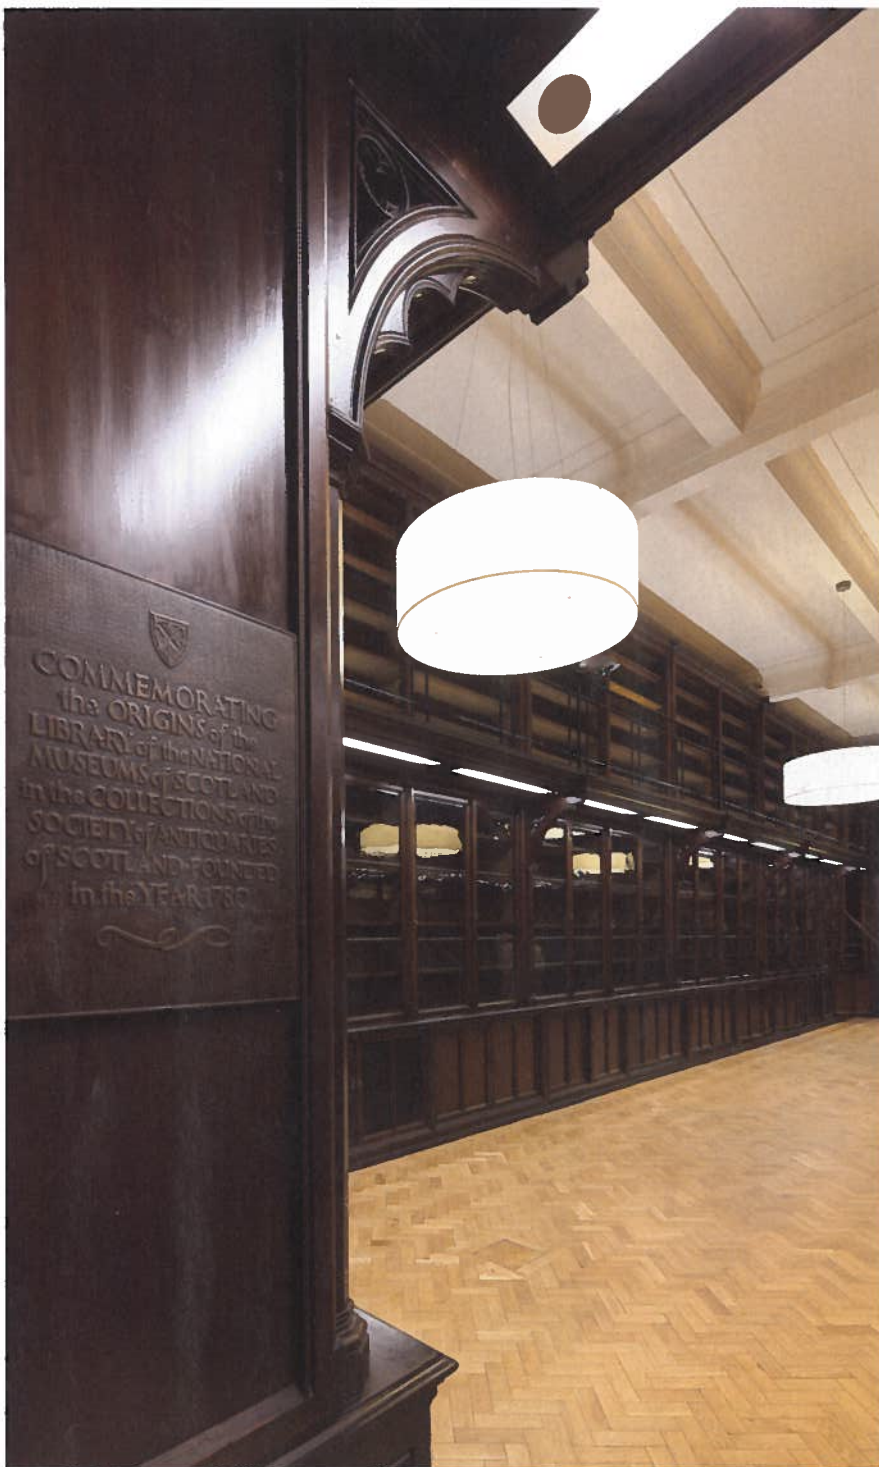
The entire mahogany-paneled library was cut up and reassembled on the opposite side of the building

Previous visitors to the Scottish National Portrait Gallery could today find themselves disoriented when entering the building's library, a mahogany-panelled room with an iron balcony running around it. In a Houdini-esque feat of illusion, the entire structure has been dismantled in sections and moved from its original room on the top floor of the east wing down to a room on the first floor of the west wing to be reassembled.

"For our team of joiners, the library has been their life for the past six months," says Thornton. "Every piece had to be removed, numbered, then moved piece by piece like a giant jigsaw puzzle."

Even more impressive is the fact that the new room was smaller than the original by approximately 0.5m in each direction, so the wood had to be cut to specific dimensions to ensure a good fit. Open to the public for the first time, the reinstated library will include an area for visitors to relax and read, plus a private area for researchers to explore the photography and

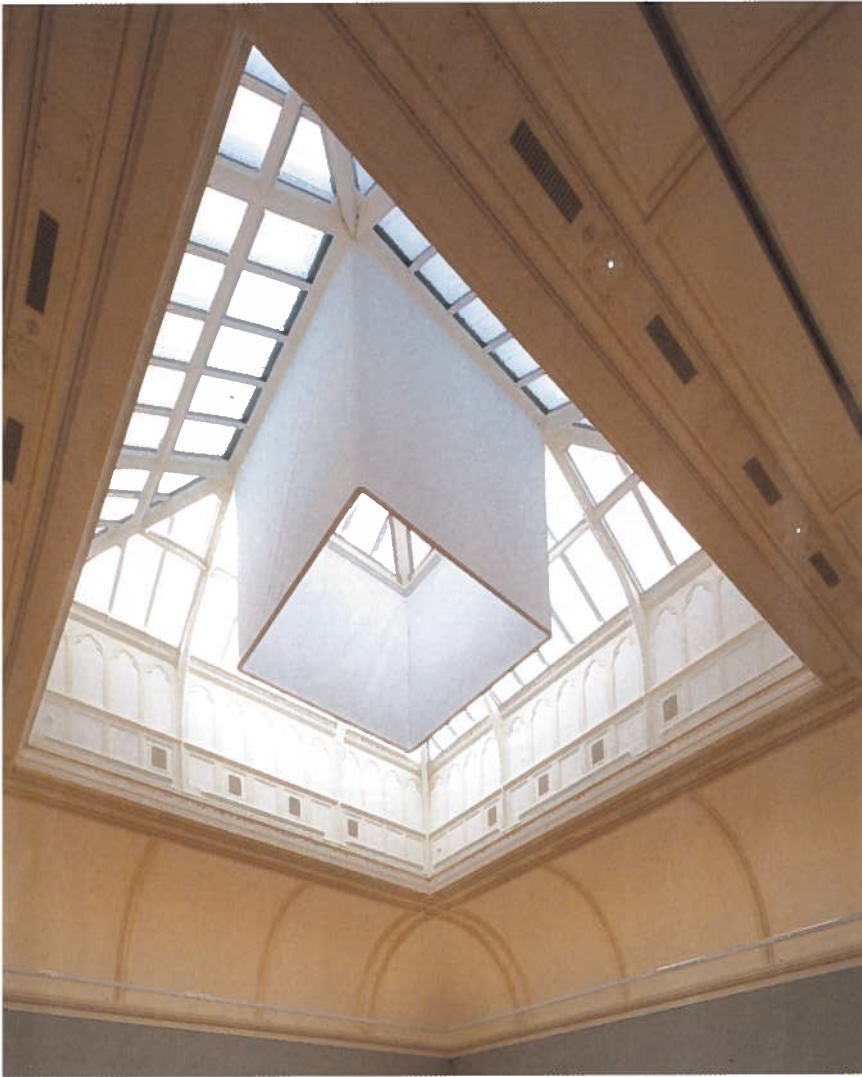
Above and below:
Many rooms previously used for storage had the most potential as gallery spaces, such as this second floor space in the west wing
